White Rock Meeting

June 7, 2023

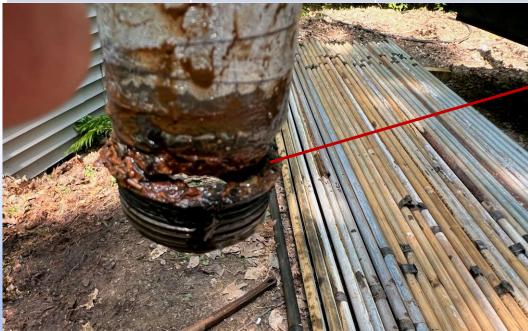
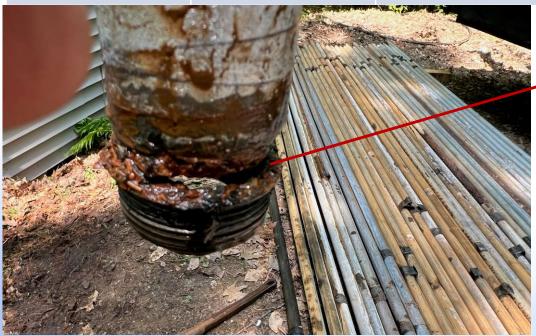
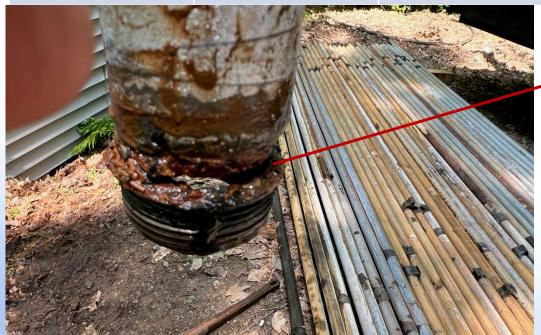
Hole in pipe at Pump 1 connection

Well 1 pump (see picture) exhibited wear and tear, and had a hole in the discharge pump.

Pump 1 was replaced and length of pipe with the hole was removed.
